DOCUMENT NO. D290-75303-2 Vol. III

TITLE IUS Program: Shock Analyses and Shock Tests

This volume of D290-75303-2 contains shock analysis and shock test results performed in support of the Inertial Upper Stage (IUS) program.

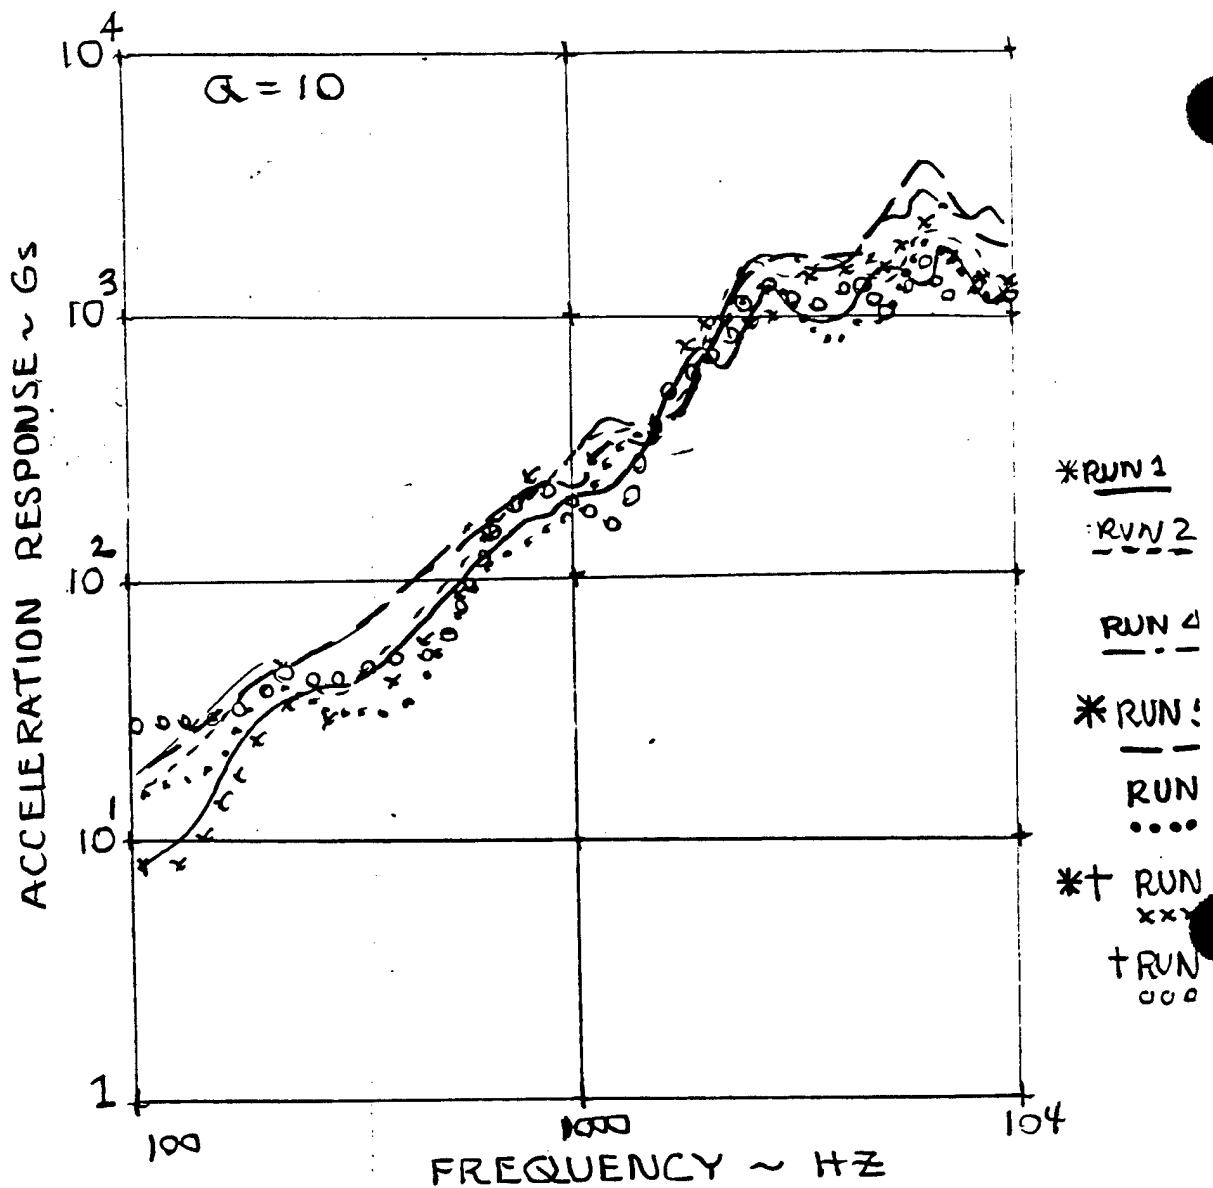
* WITHOUT RETAINER + FREE NUT REMOVED

SHOCK SPECTRUM COMPARISONS
 IUS STAGE 1/2 SEPARATION NUT
 MEASUREMENT 1Z
